Ballycumber Folly

Conservation Works 2019

Phase 1 works to the folly involve:

2019 Programme of works

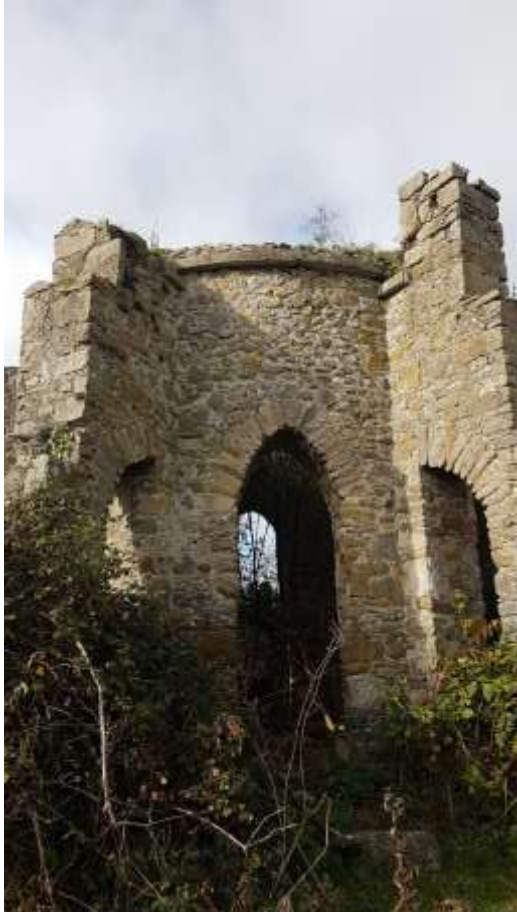
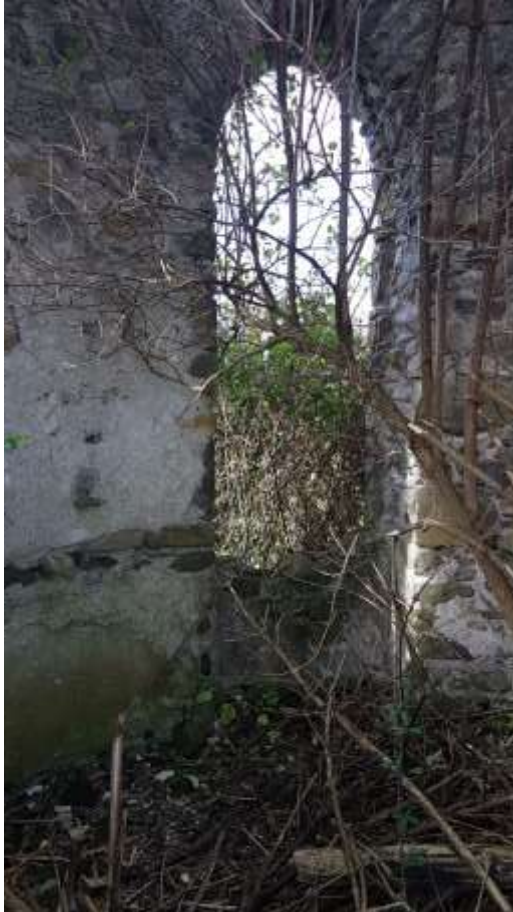
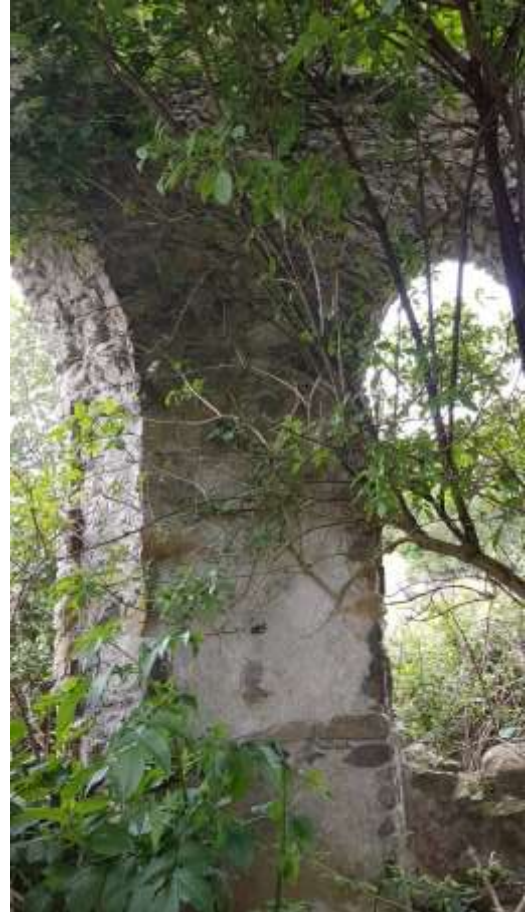
1. Ground clearance – internal and external

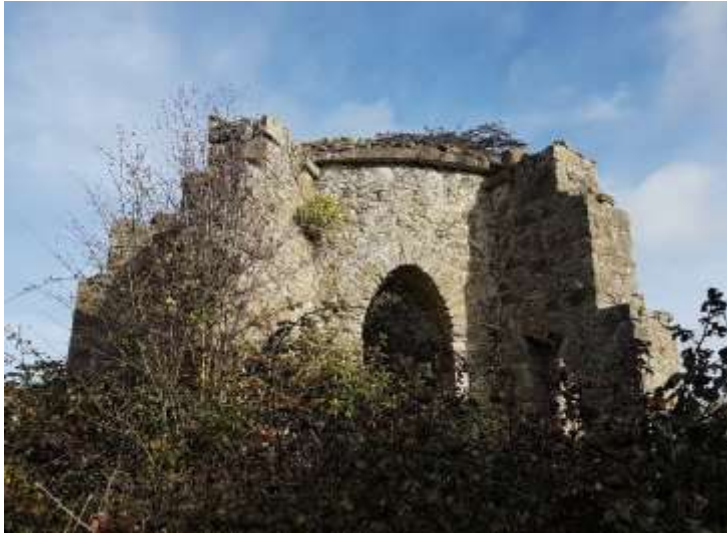
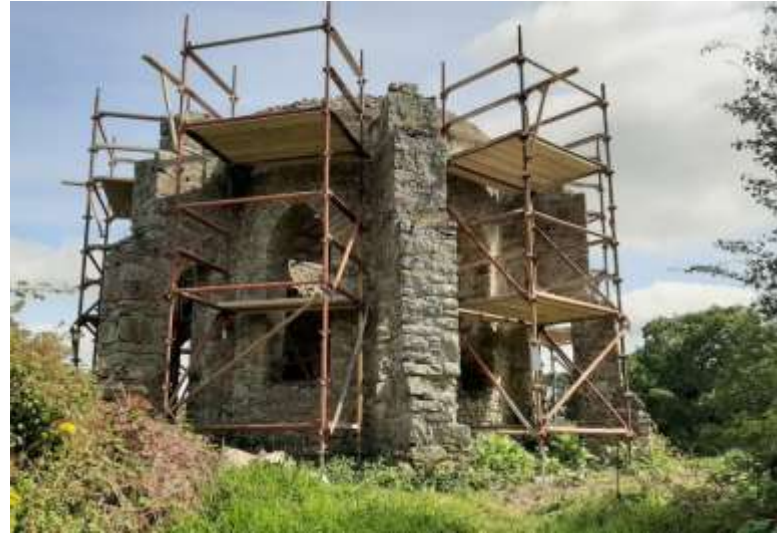
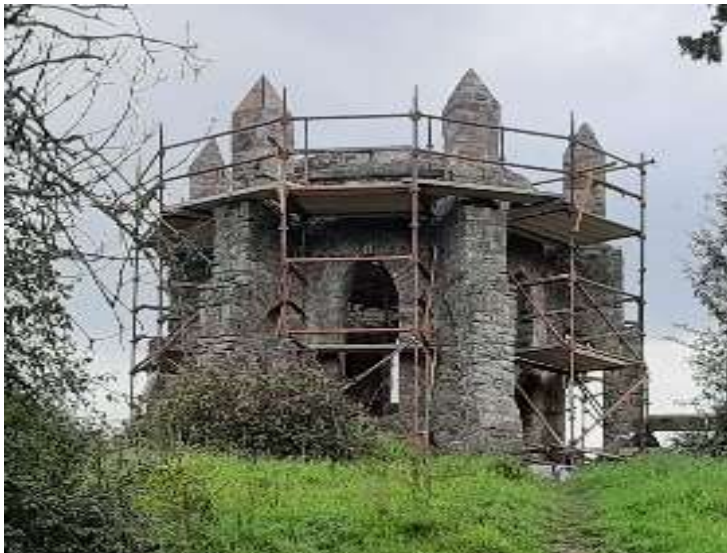
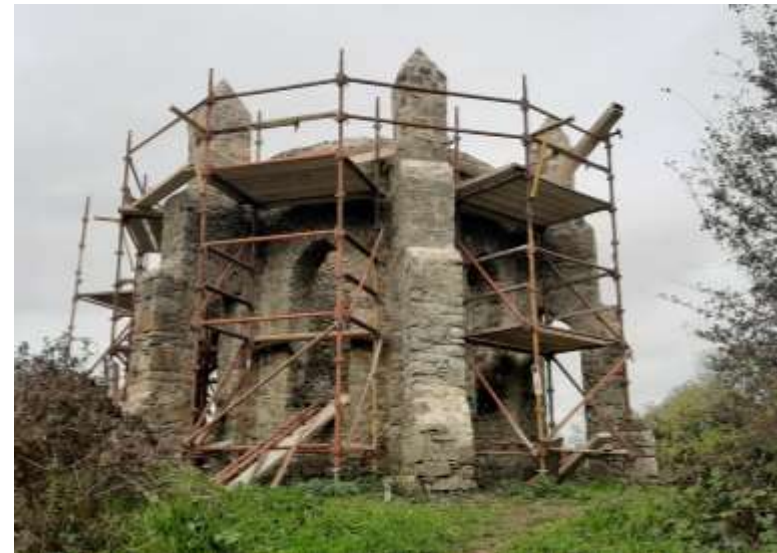
2. Vegetation removal and Scaffolding

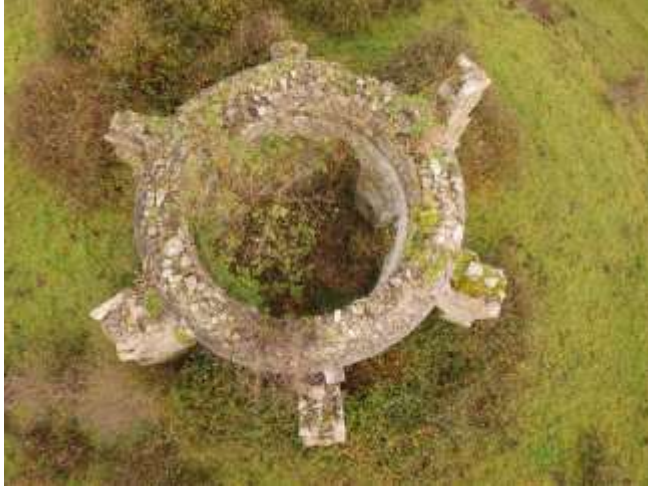
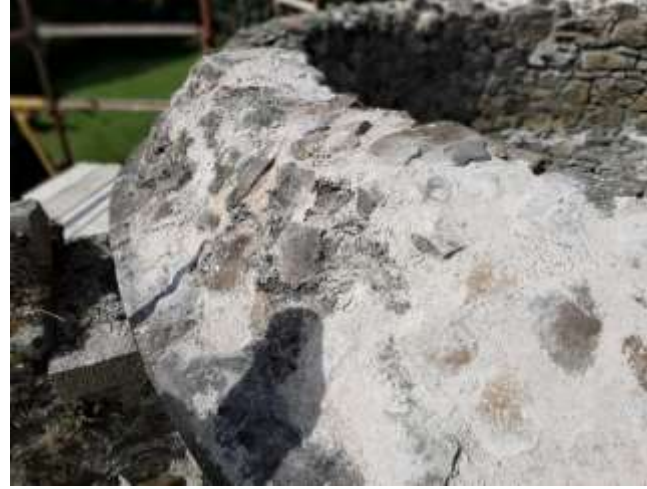
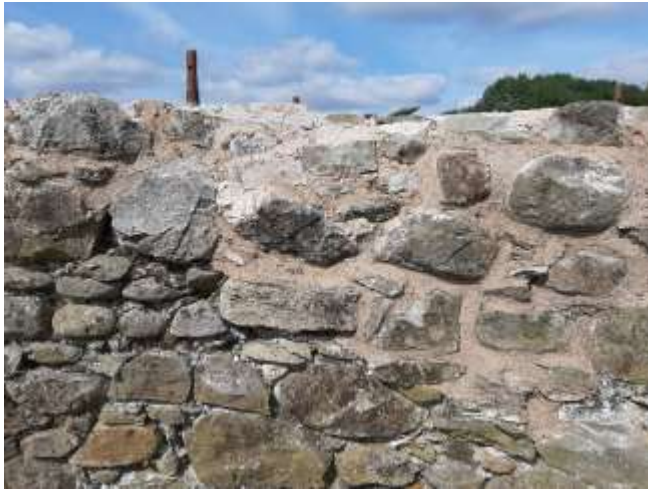
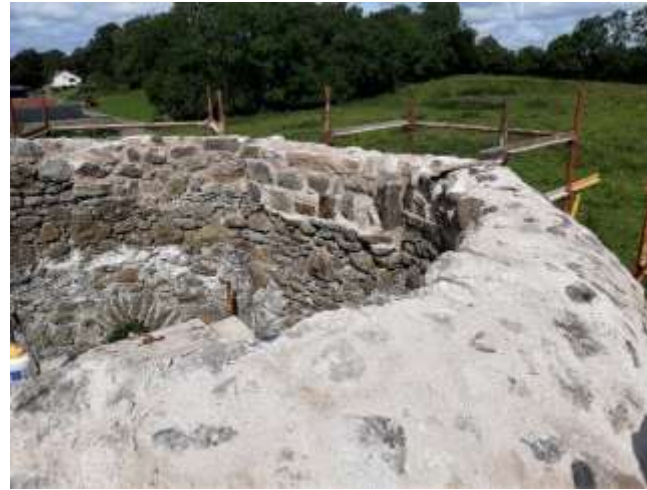
3. Consolidation of stonework

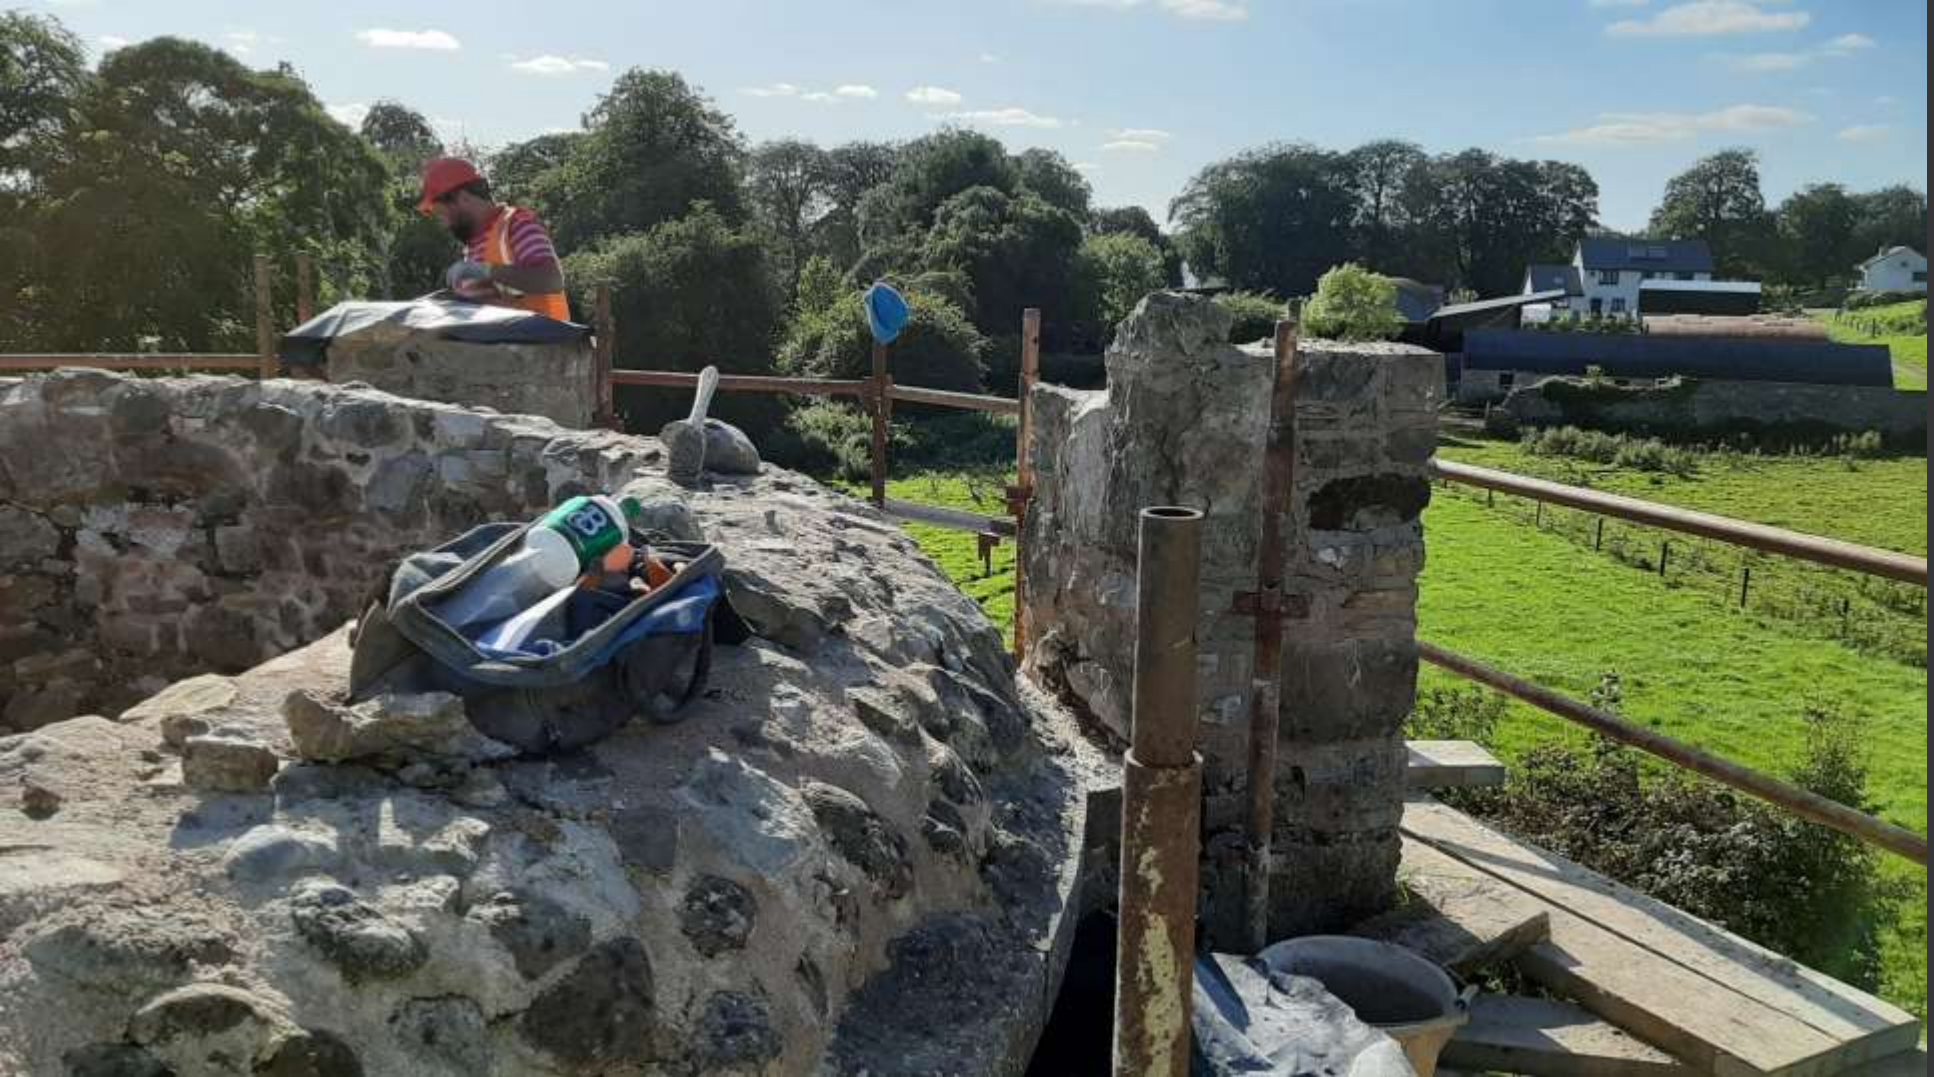
Consolidation

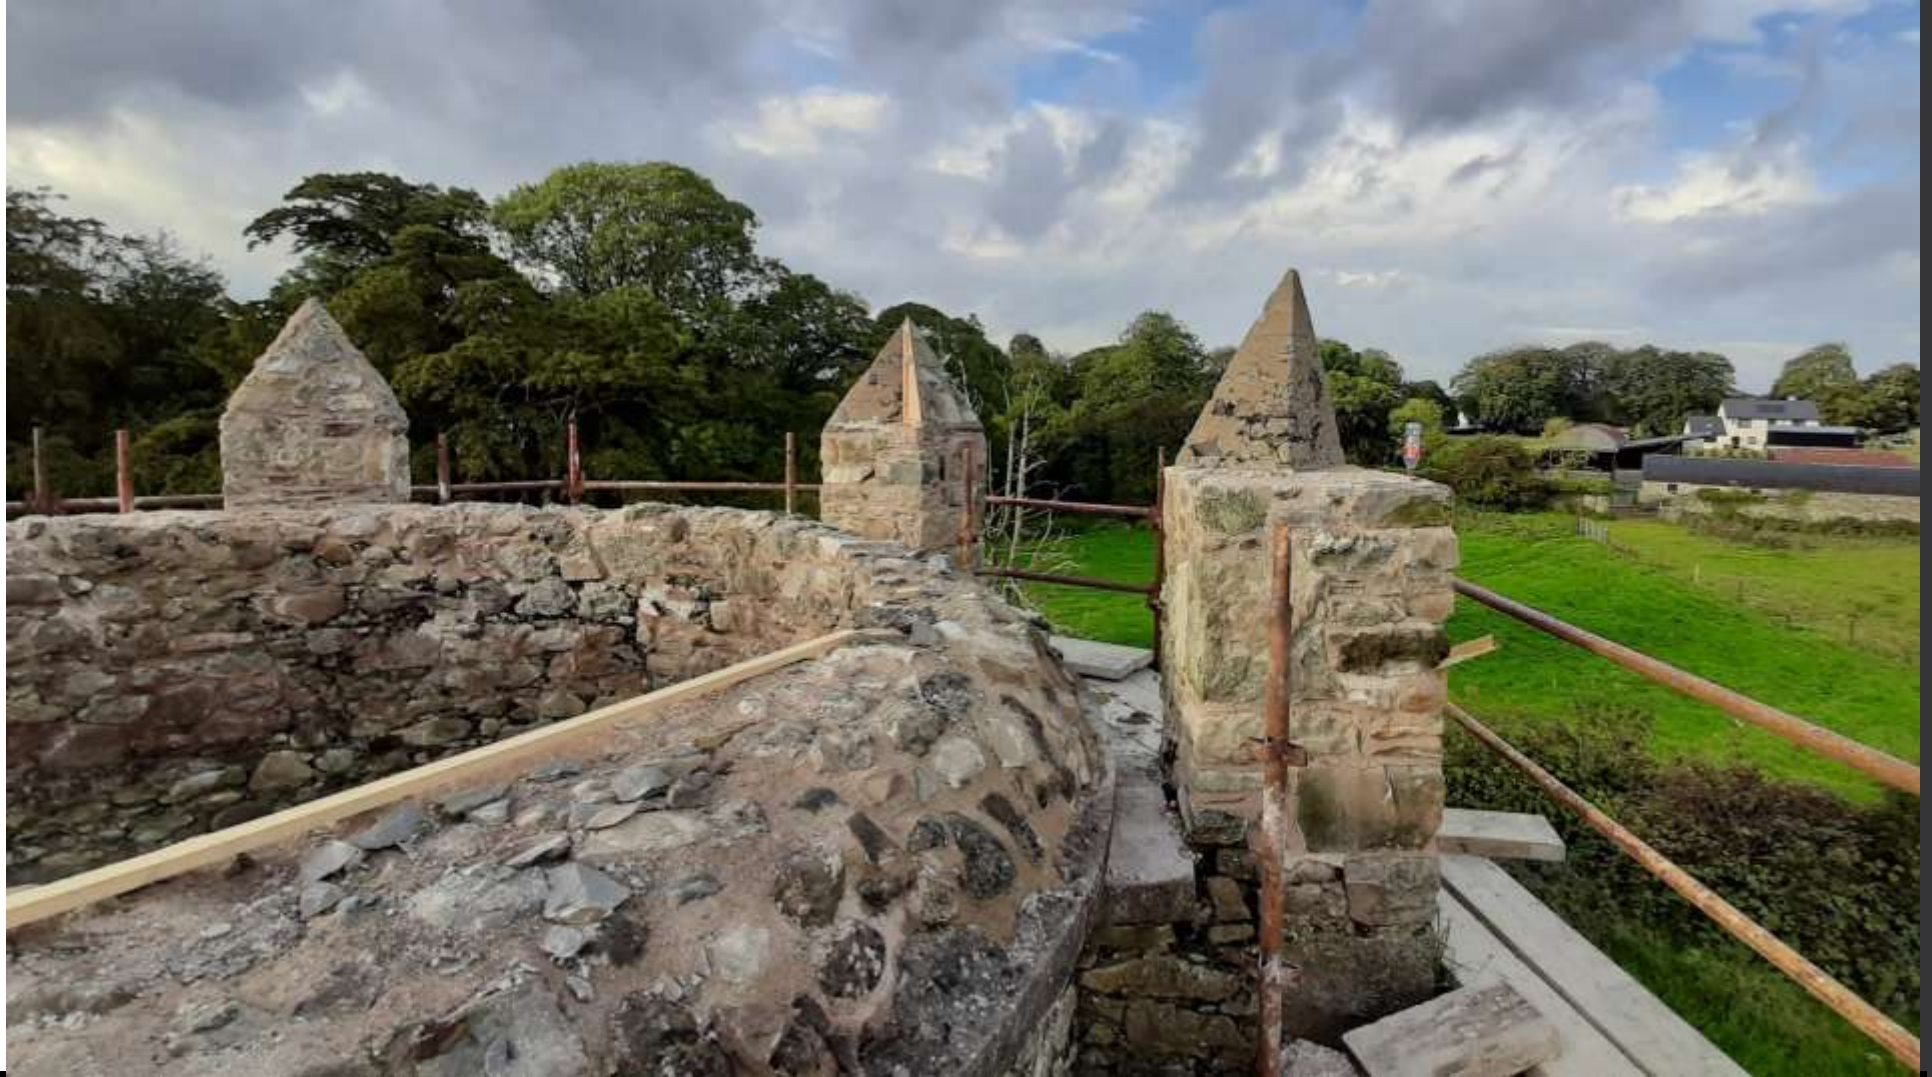
Consolidation

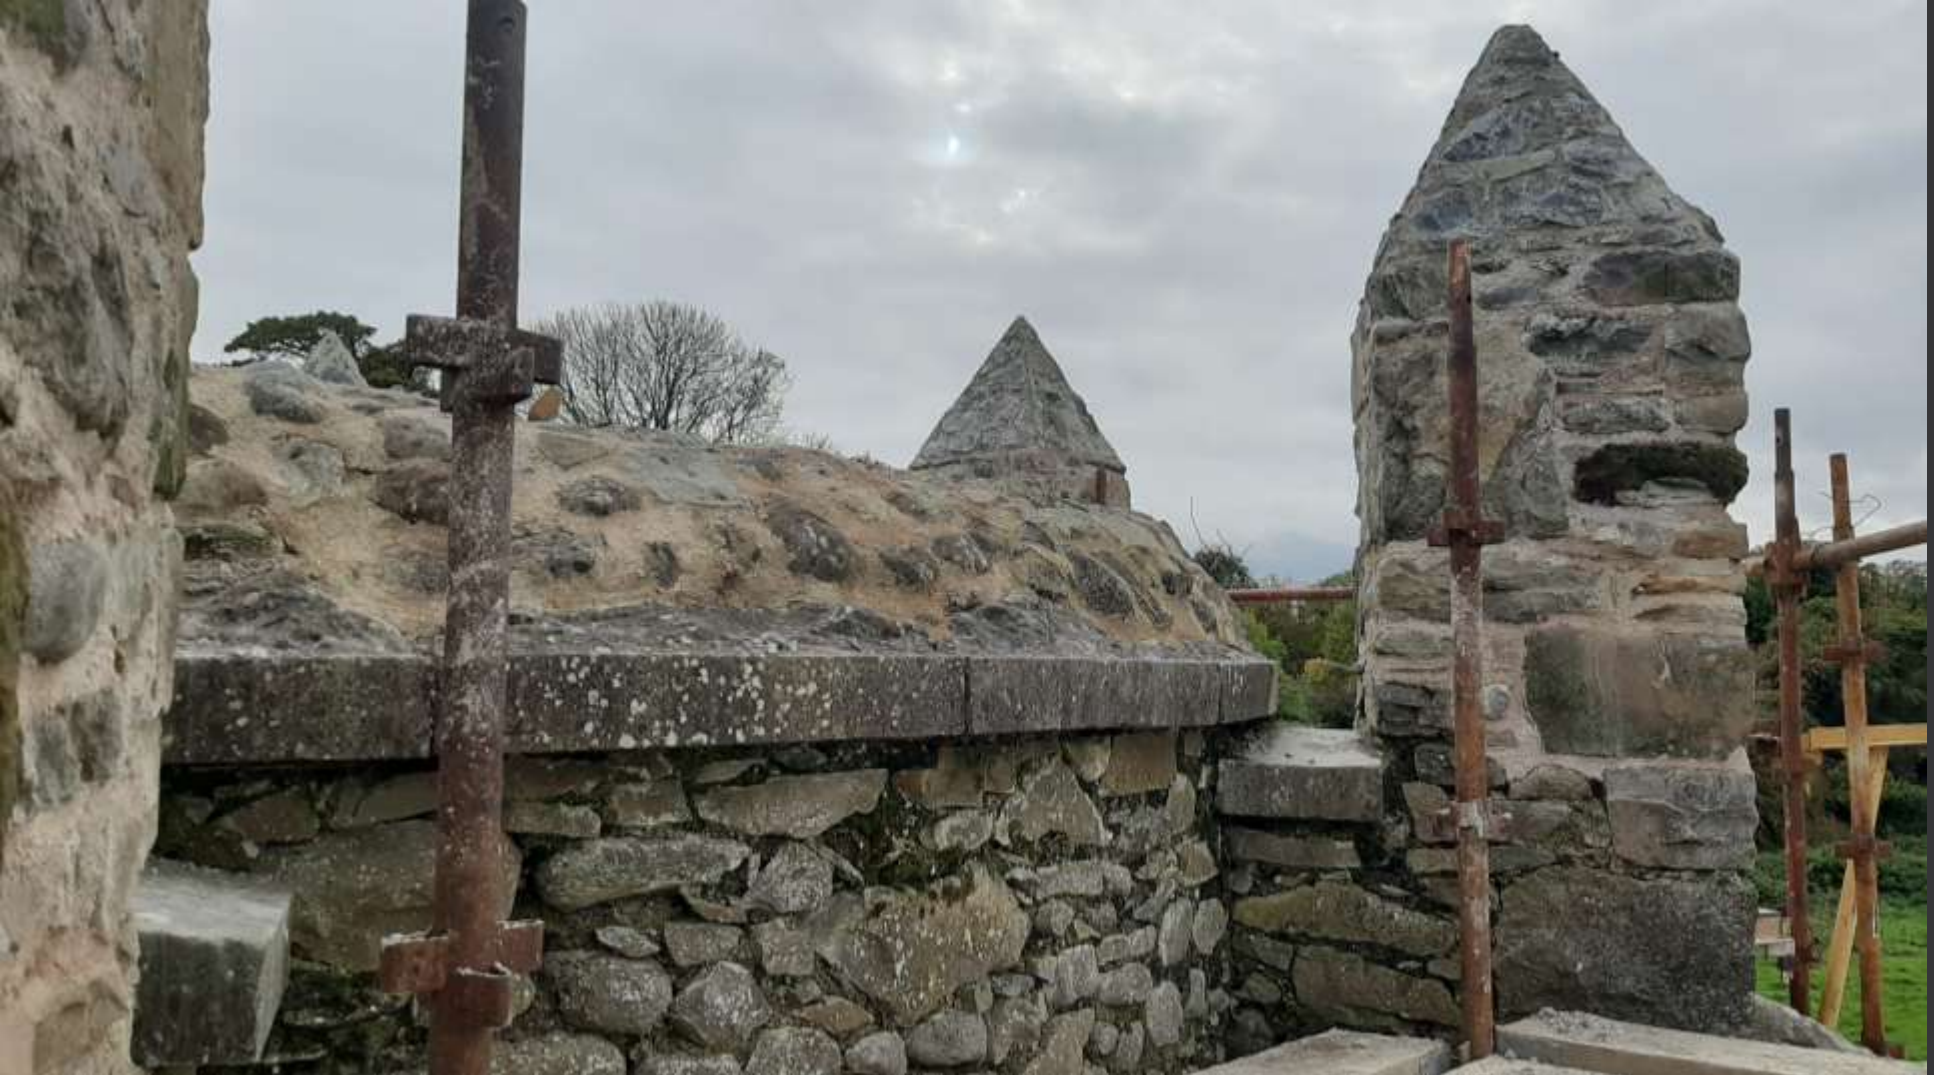
Consolidation and Buttress repair

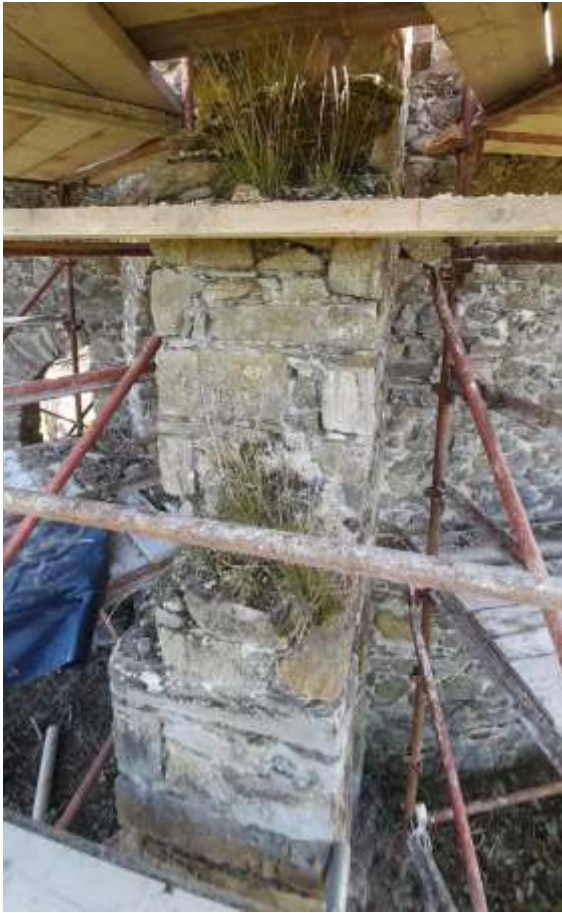
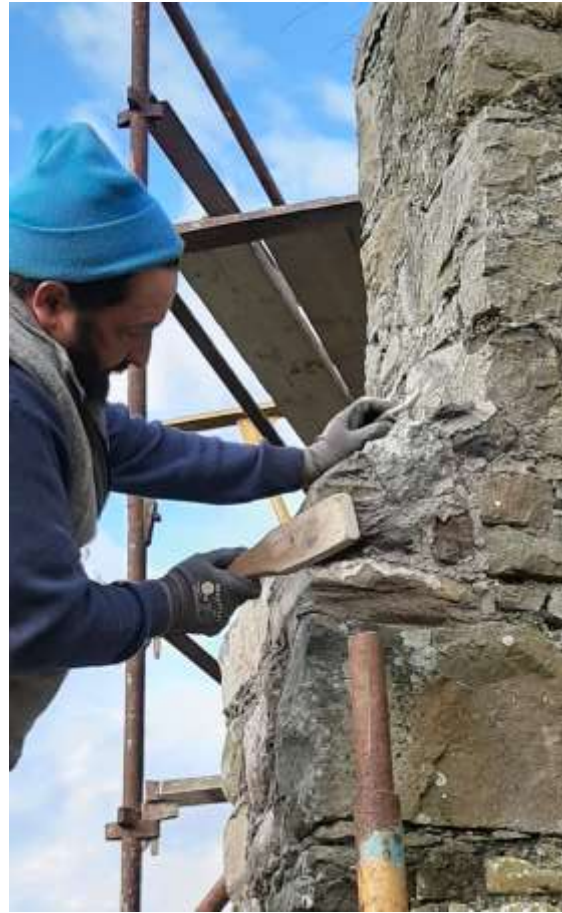
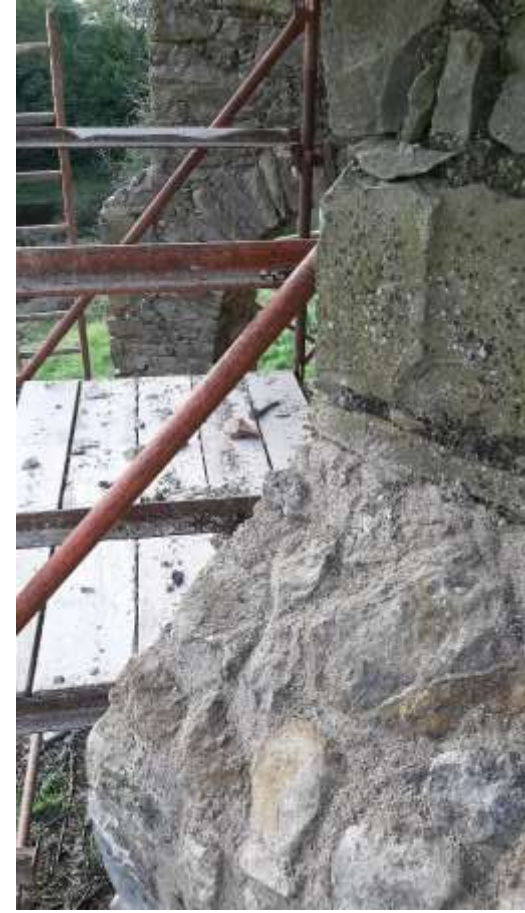
- The structure had suffered from ivy establishment and dissolution of the mortar at the top of the walls and sloping masonry to buttresses, due to exposure to rain and subsequent frost action.
- This had resulted in the unfortunate deterioration to the stonework rubble masonry above eaves level, but the eaves cut stones remained in position.
- Works involved treating and removing ivy.
- Unstable masonry was deep pointed with lime mix and pinning stones to match surrounding masonry.
- Mortar was pressed and recessed and pigmented with burnt umber to match original pointing.

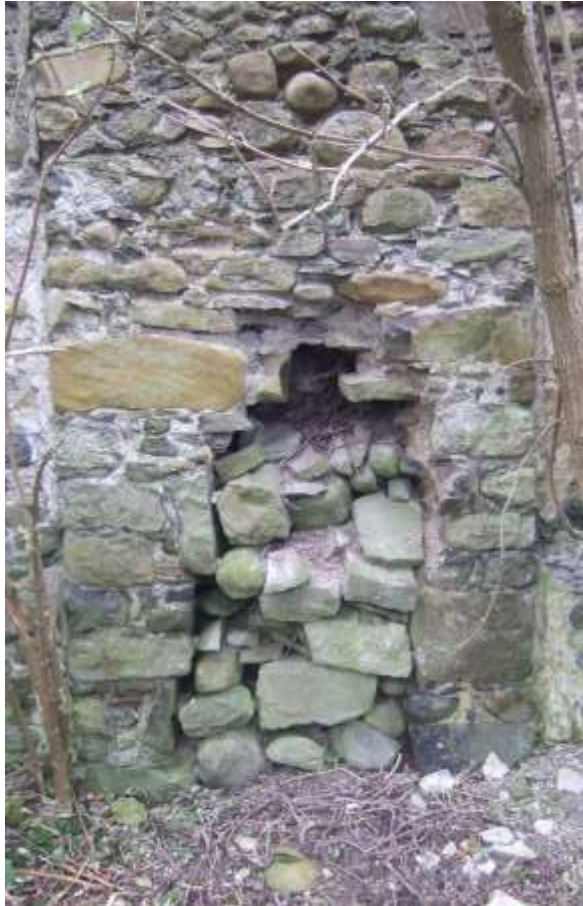
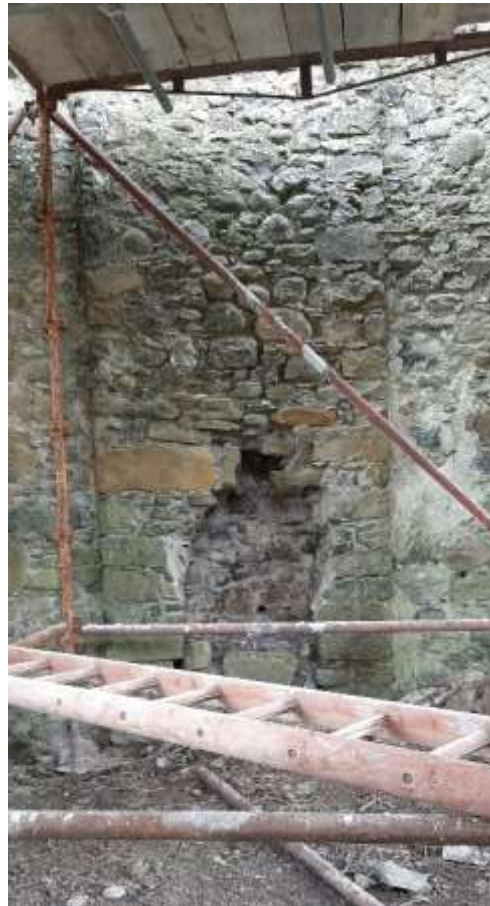
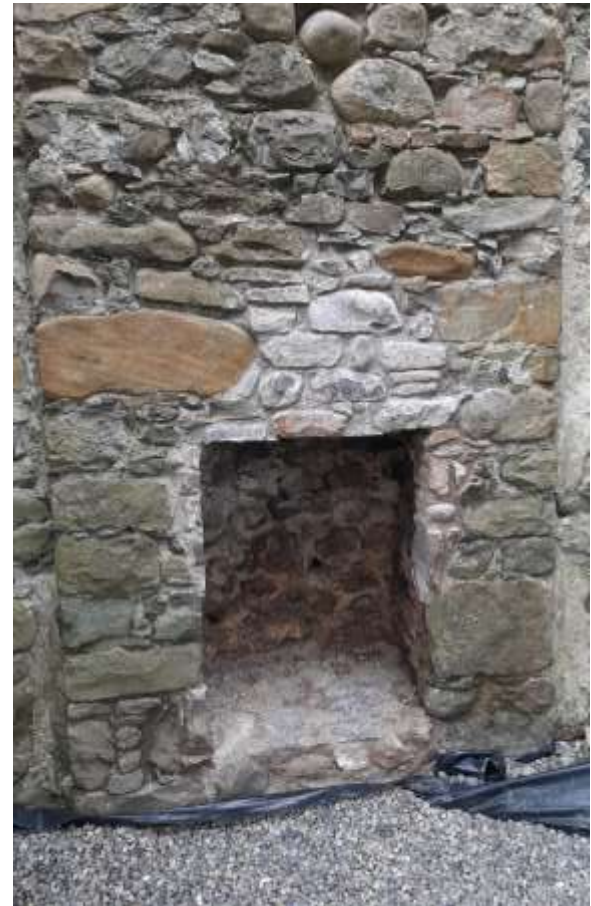
Chimney – unblock and repair

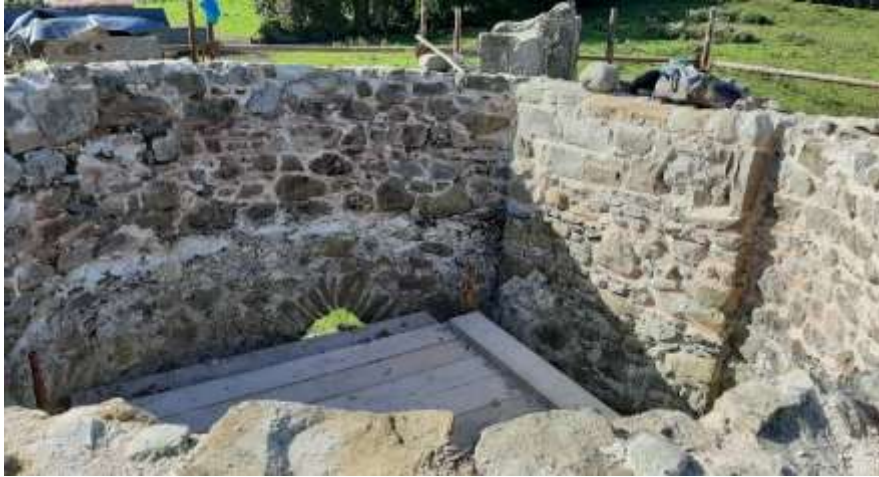
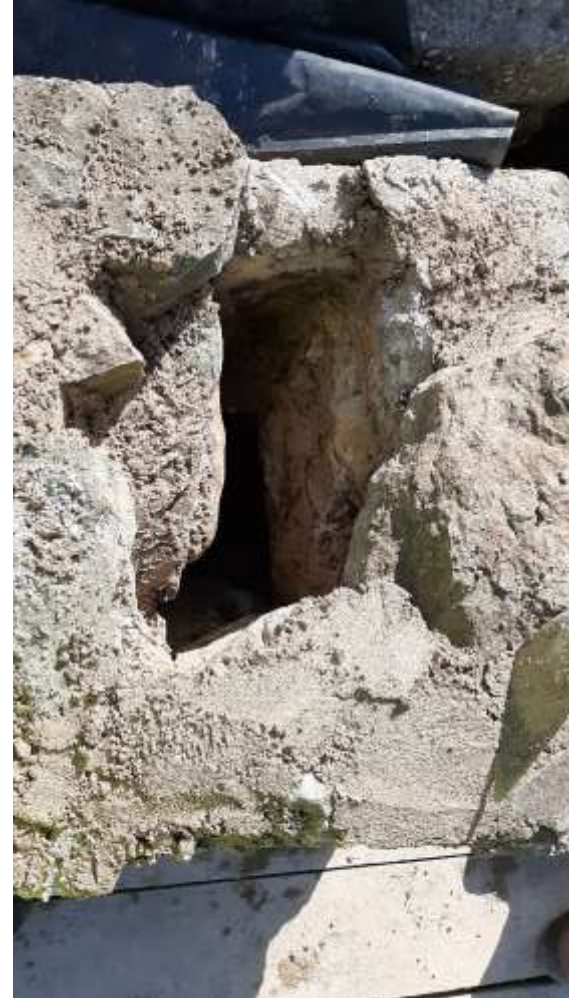
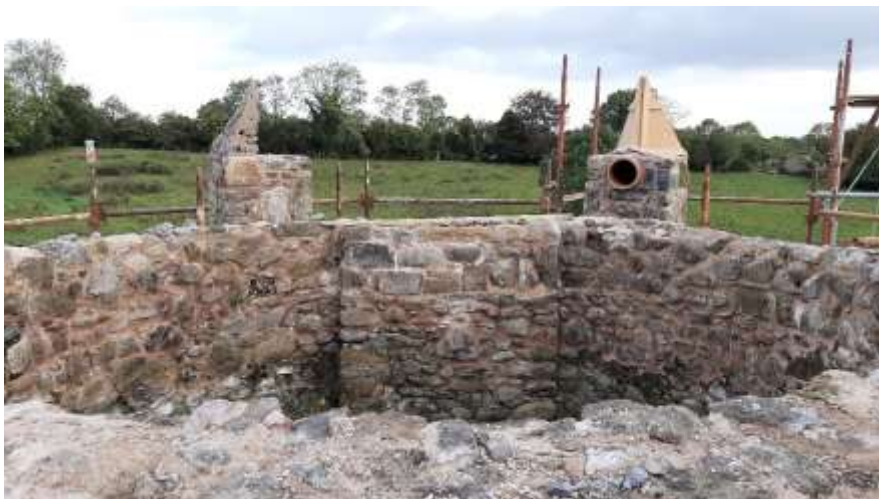
Chimney and flue (through buttress)

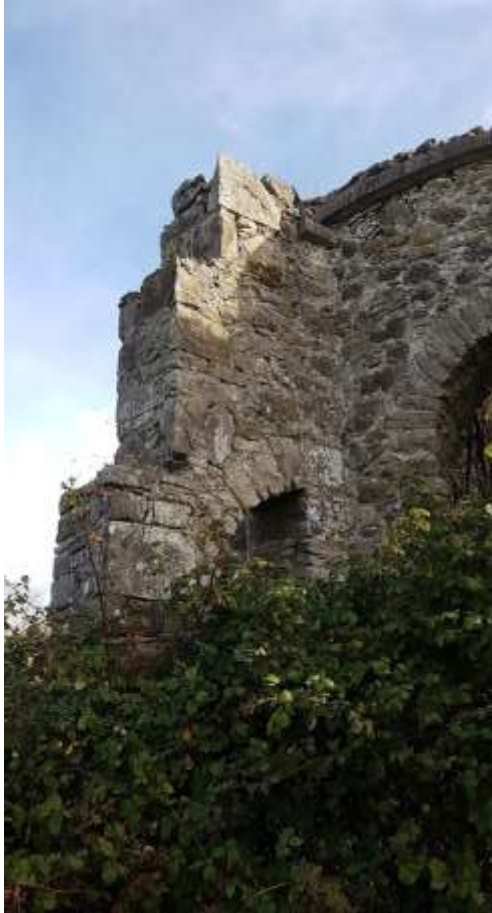
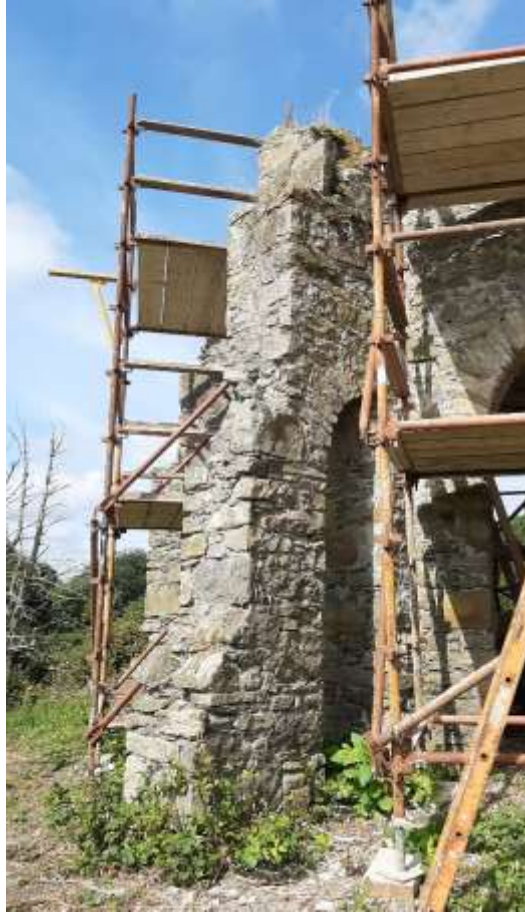
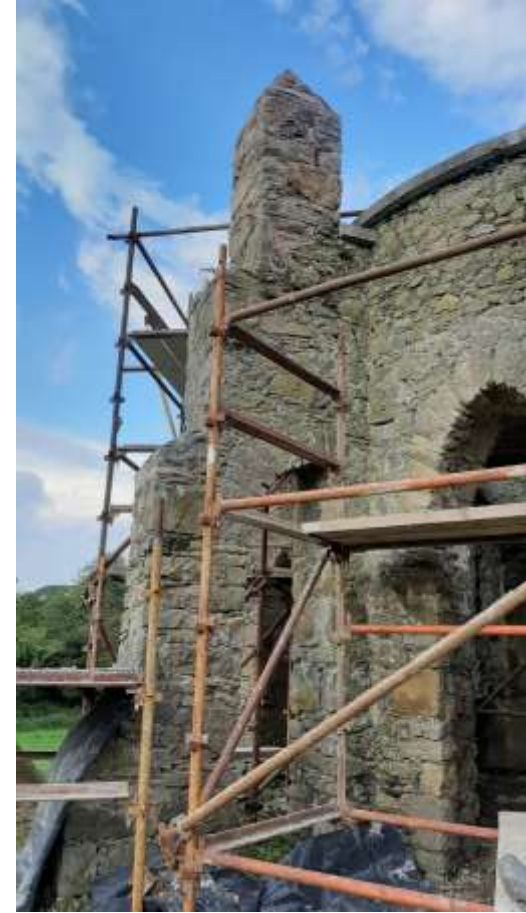
4. Buttress repair

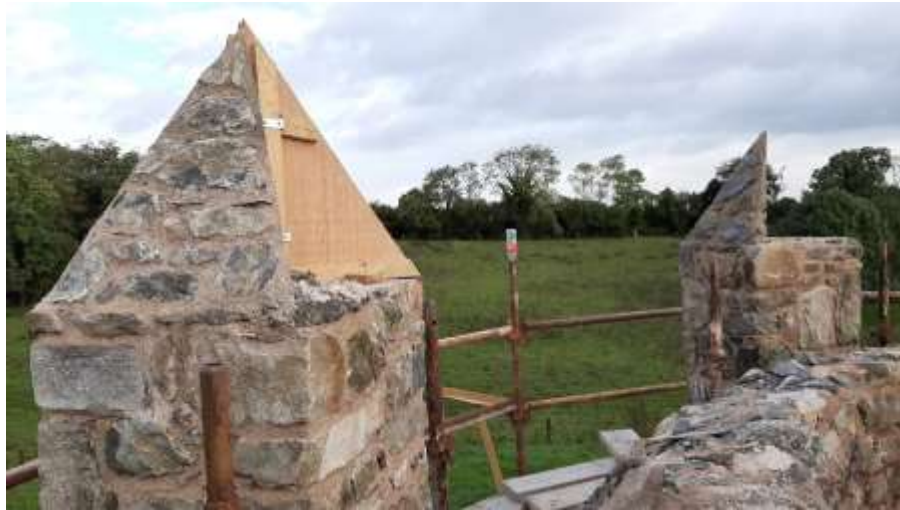
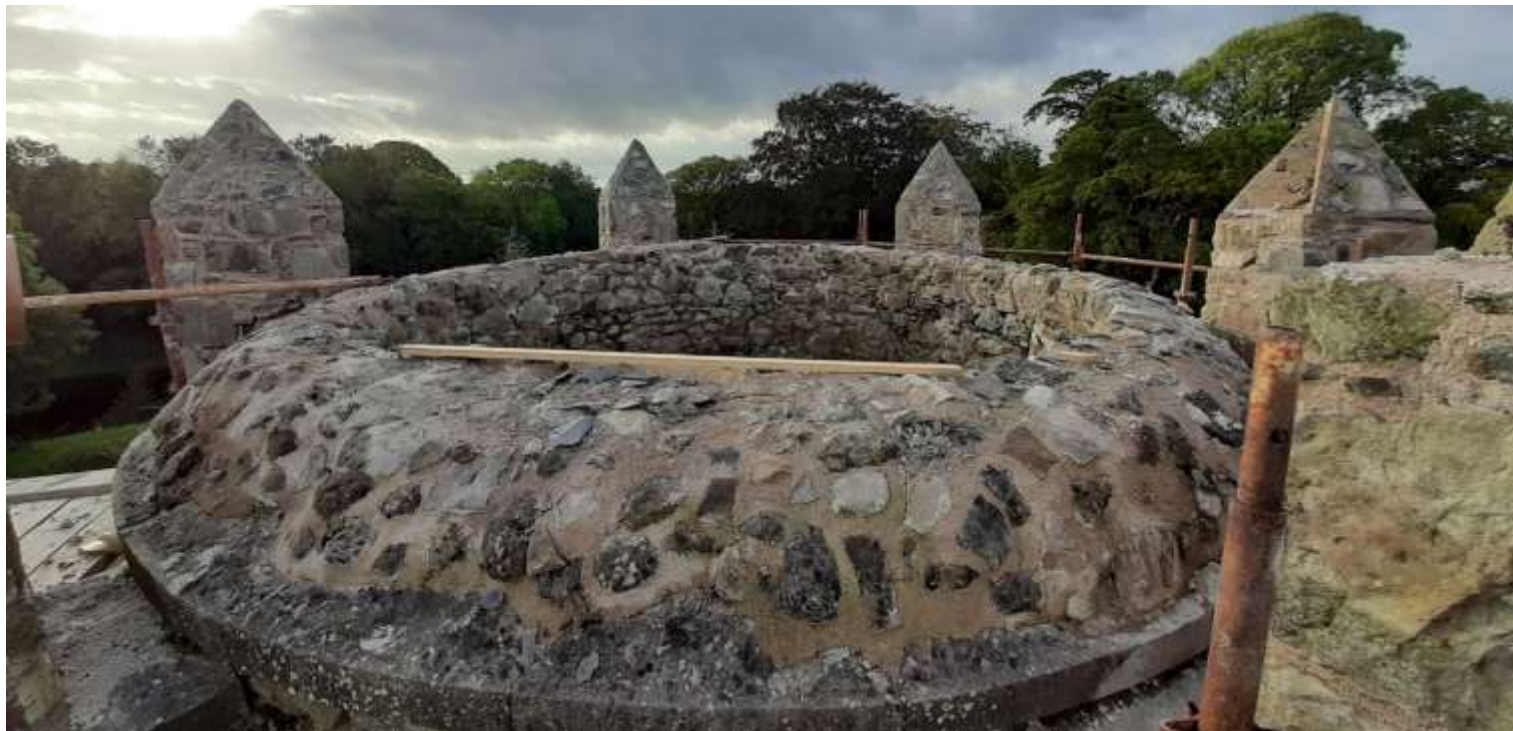
Pinnacle + flue methodology

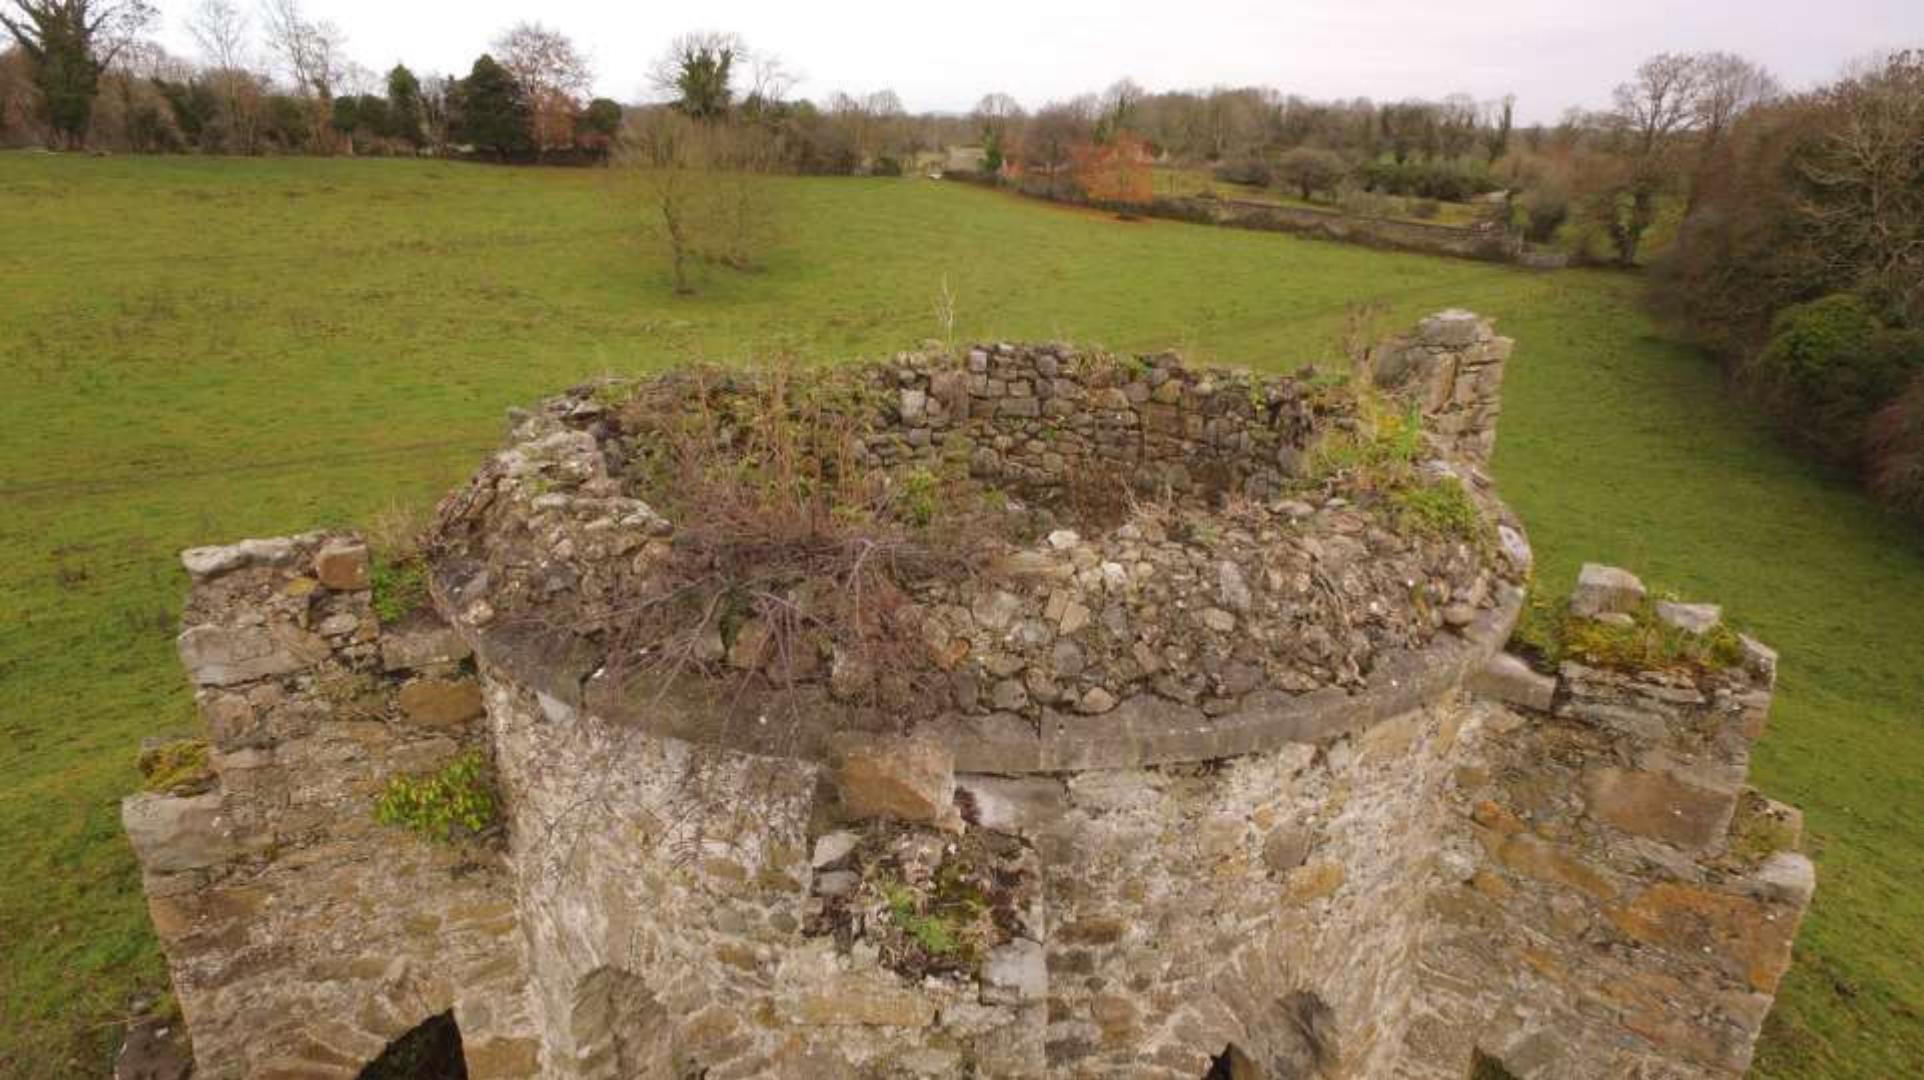
Progress to date

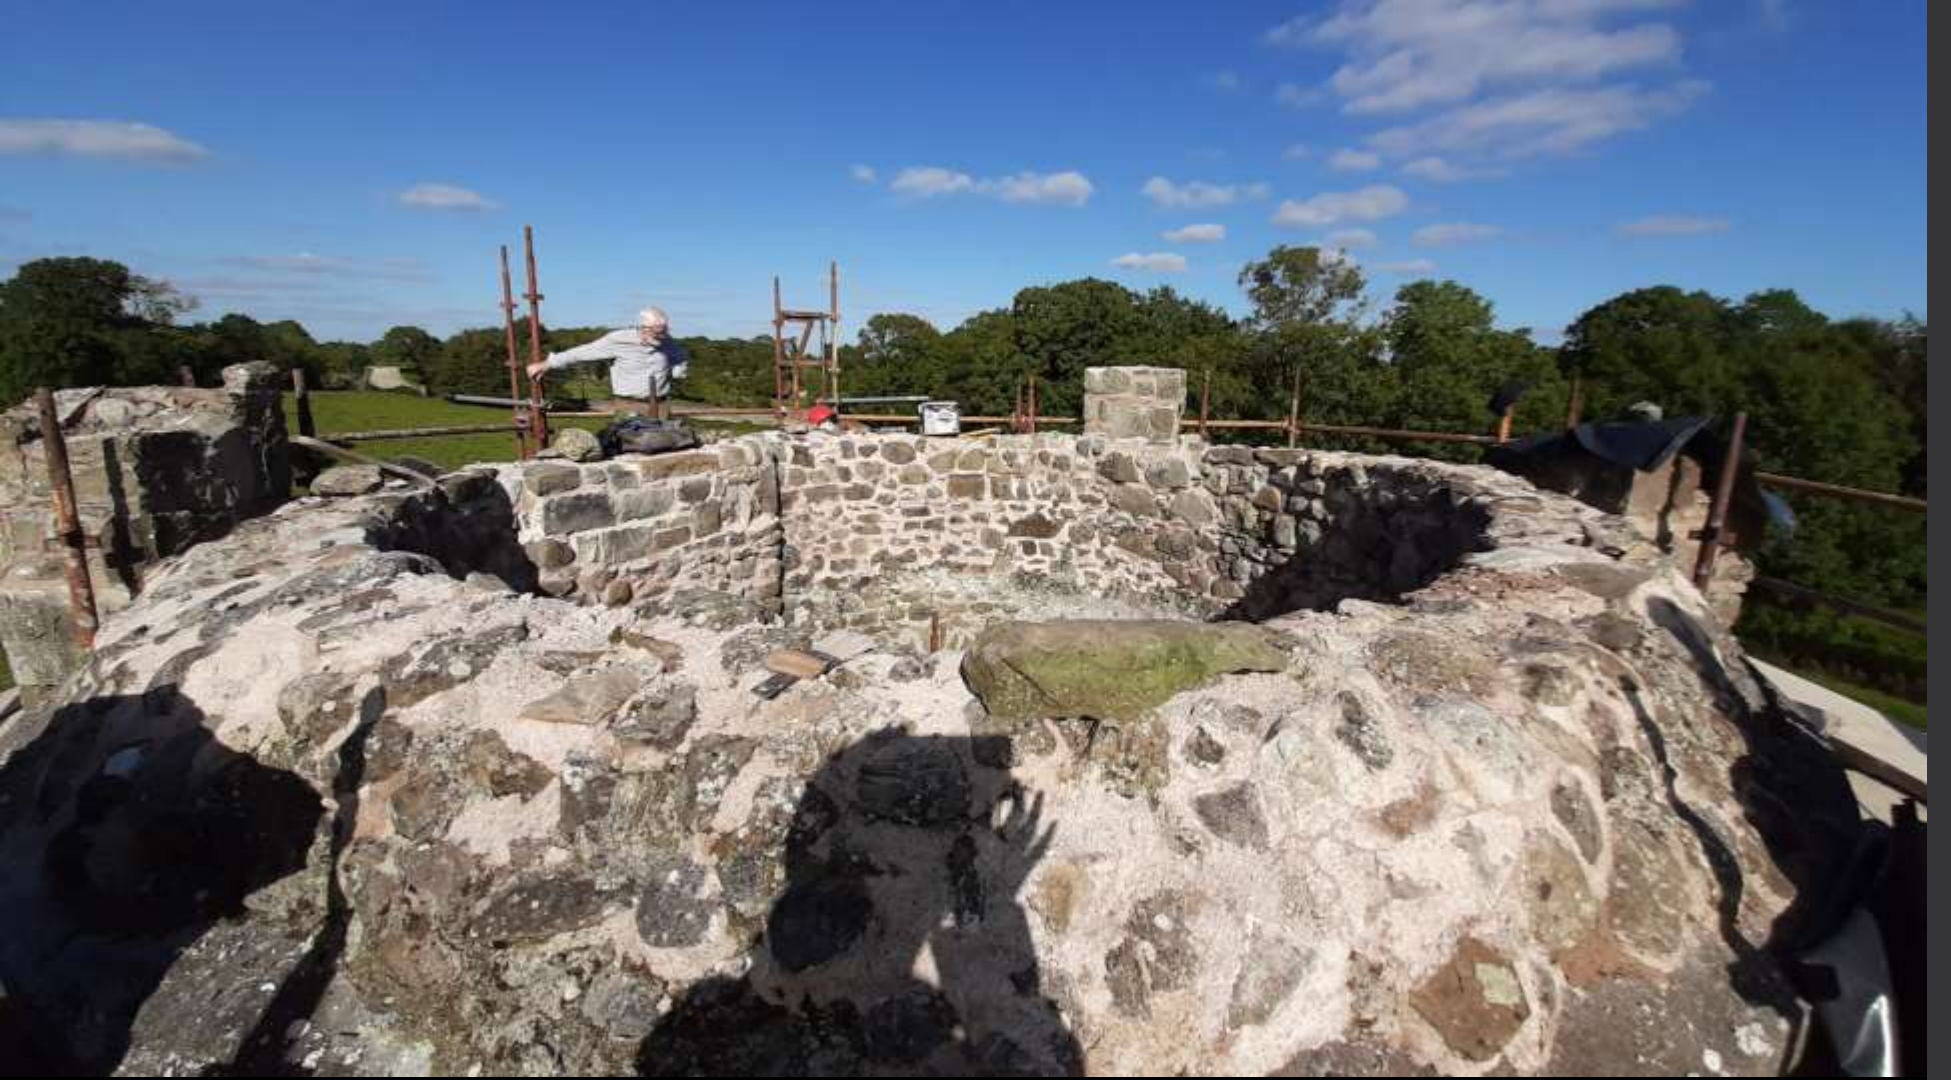
Capping and Buttress repairs
